An assessment of tree susceptibility and resistance to cyclones

A study based on Severe Tropical Cyclone Yasi 2nd February 2011

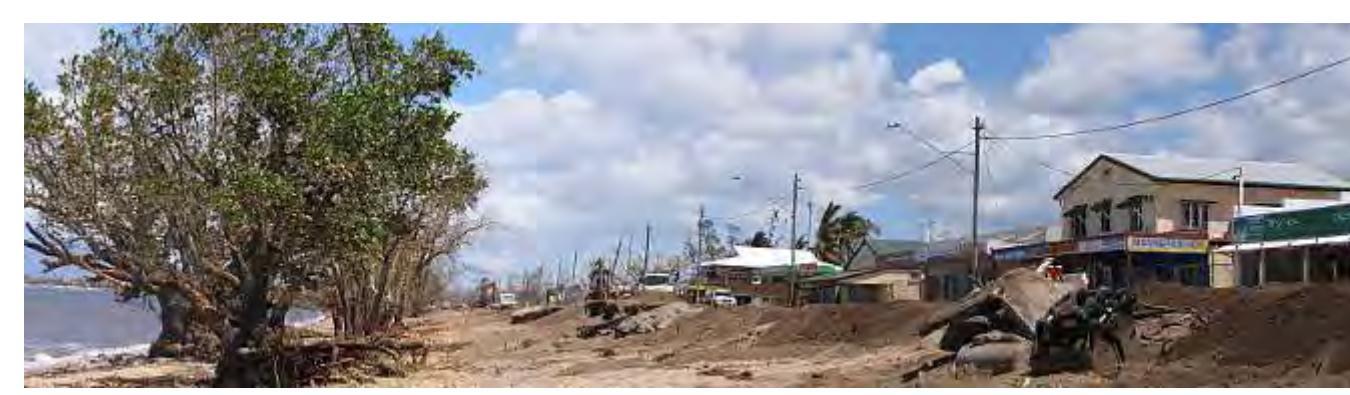
Figure 1 Storm surge impacts on Cardwell foreshore, Cyclone Yasi

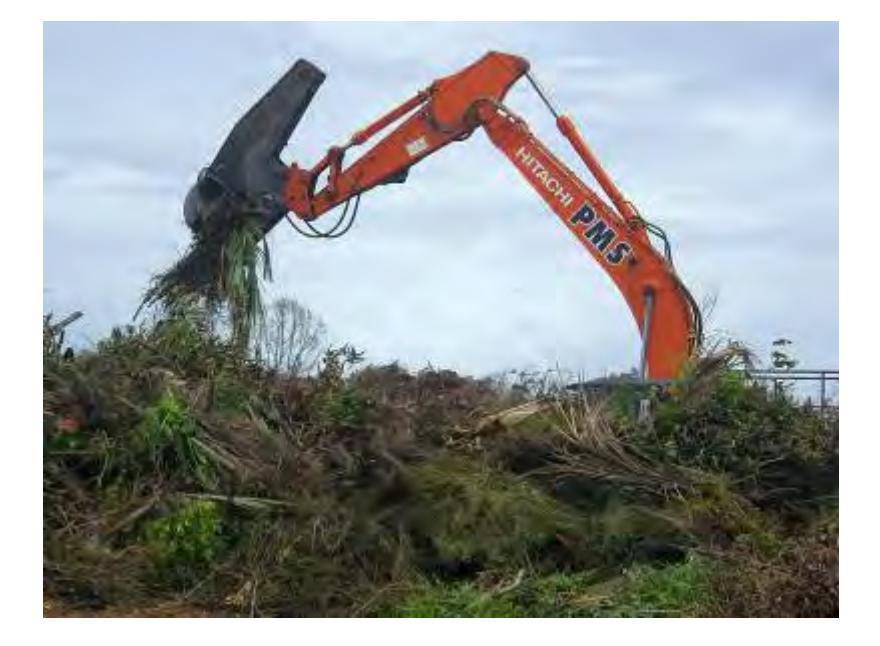
Figure 4 Greenwaste generated by Cyclone Yasi in Ayr, North Queensland

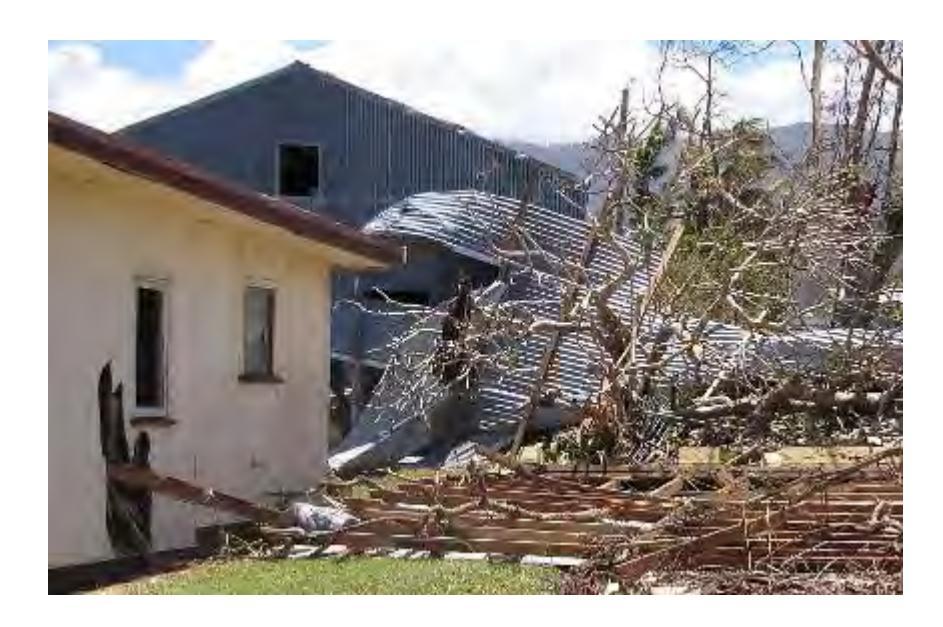
Figure 6 Building envelope breached by flying debris, Cardwell (Cyclone Yasi)

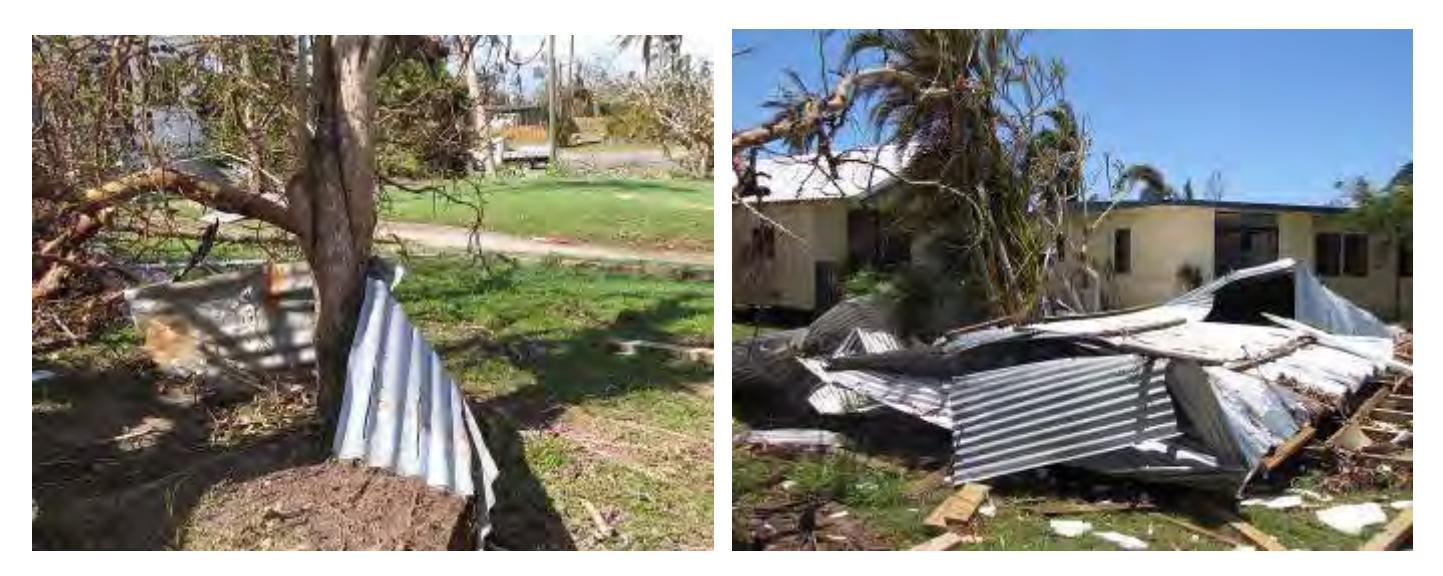
Figure 7 Examples of flying debris intercepted by trees at Cardwell, Cyclone Yasi

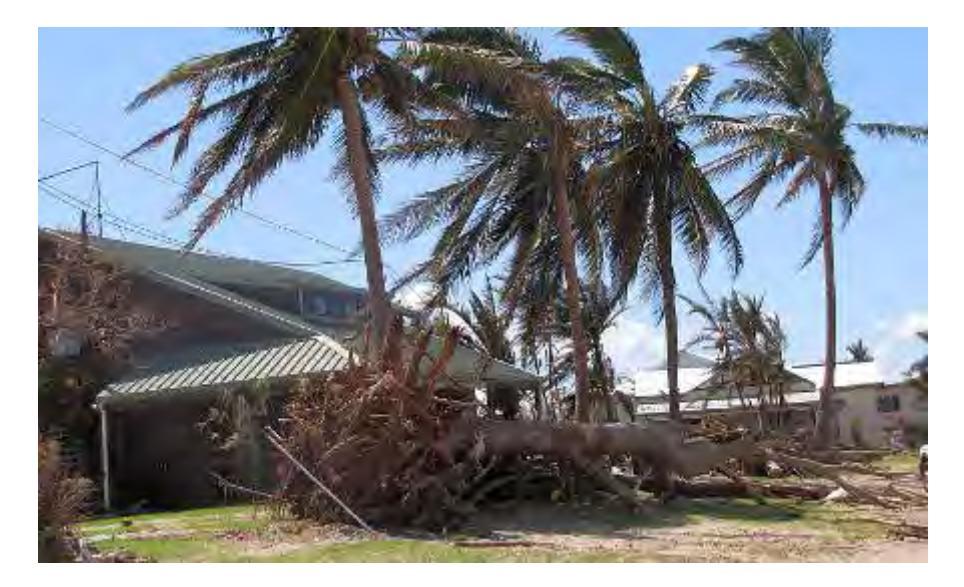
Figure 8 Debris attack can be caused by storm surge - A fallen tree trunk carried by storm surge is prevented from impacting the building by a row of palms (Cardwell – Cyclone Yasi)

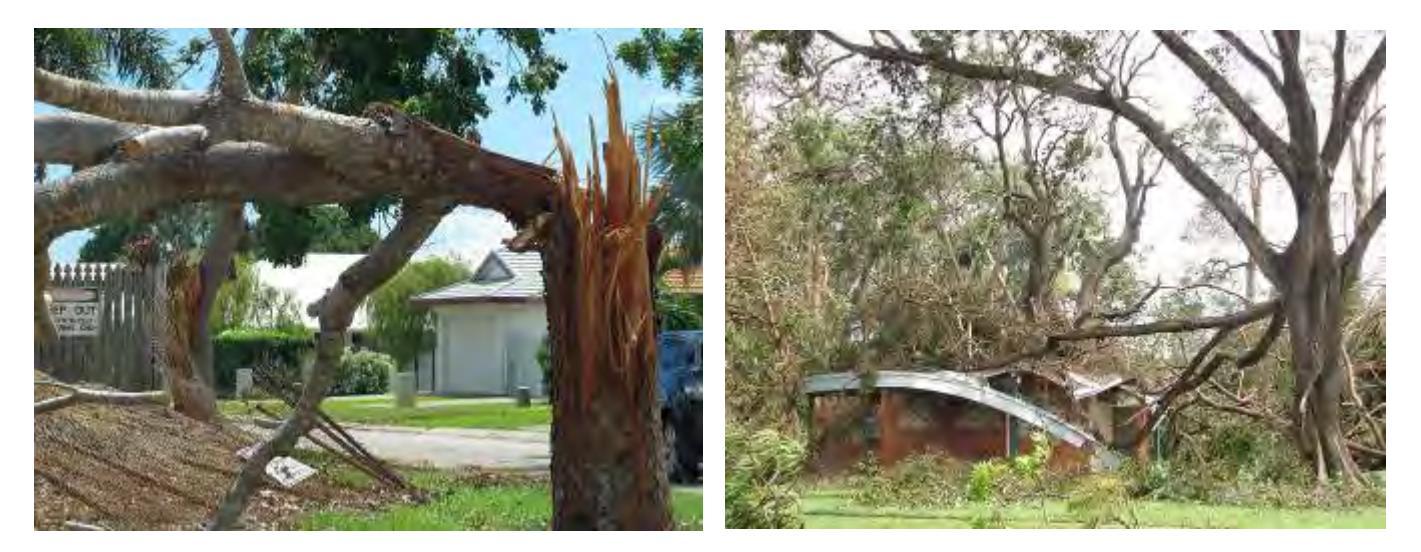
Figure 9 Failure of large branches (e.g. Terminalia) and trunks (e.g. Khaya)

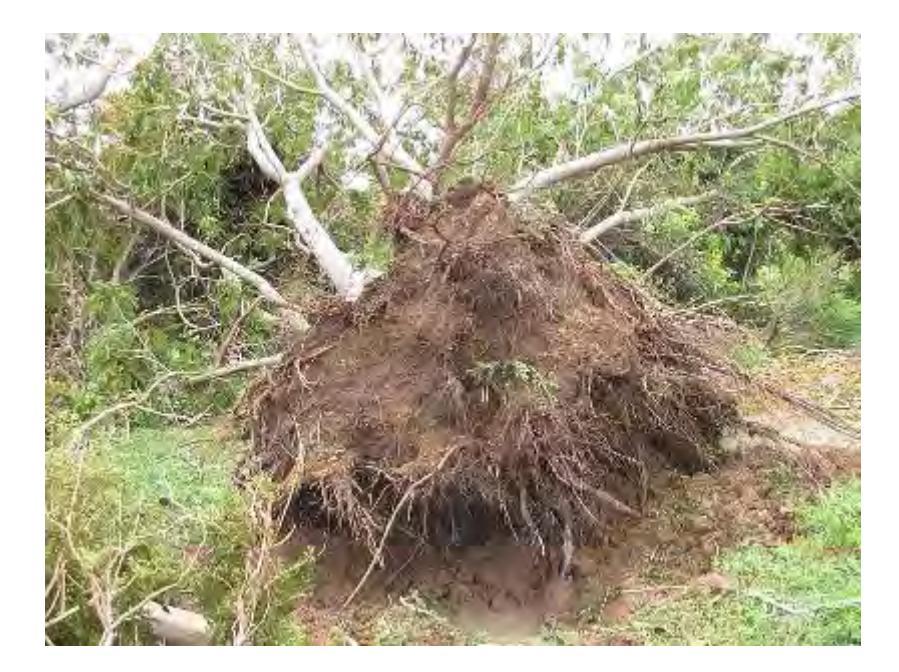
Figure 10 Root ball failure in yellow flame tree (Peltophorum pterocarpum)

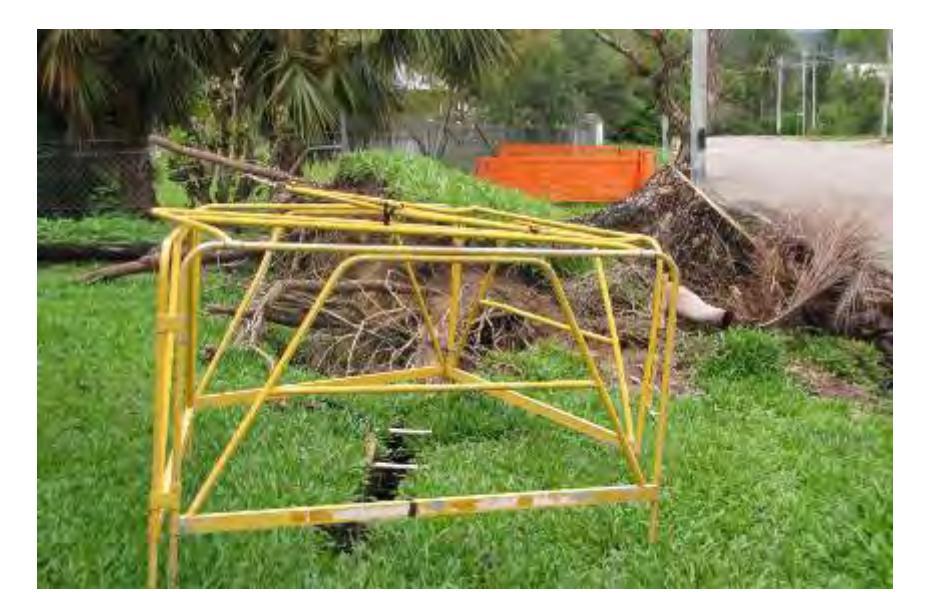
Figure 13 Damage to underground services by an uprooted Indian siris

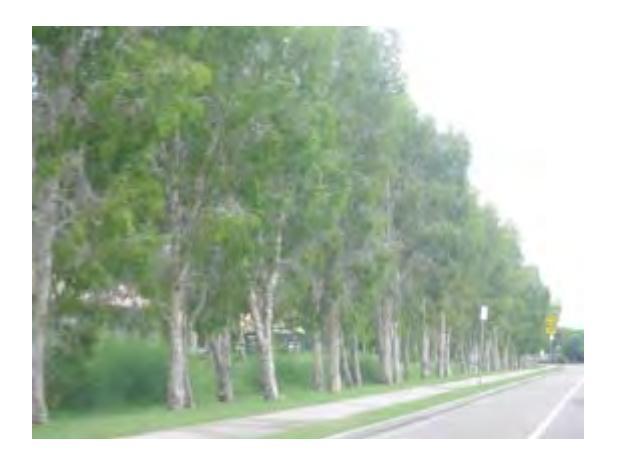
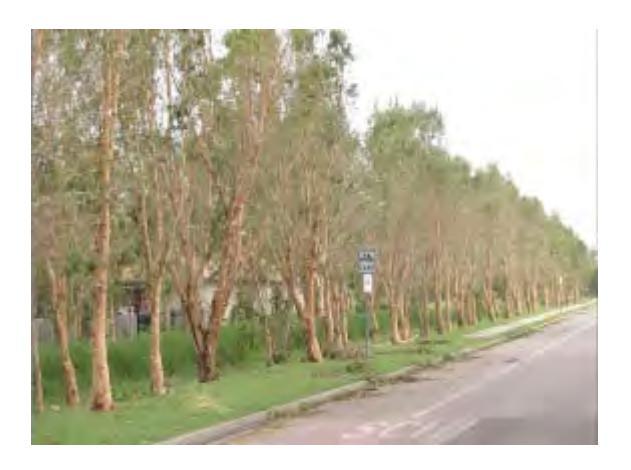
Figure 15 Damage to Peltophorum (100%) and Khaya (87.5%) on William Anglis Drive, Annandale (before and after)

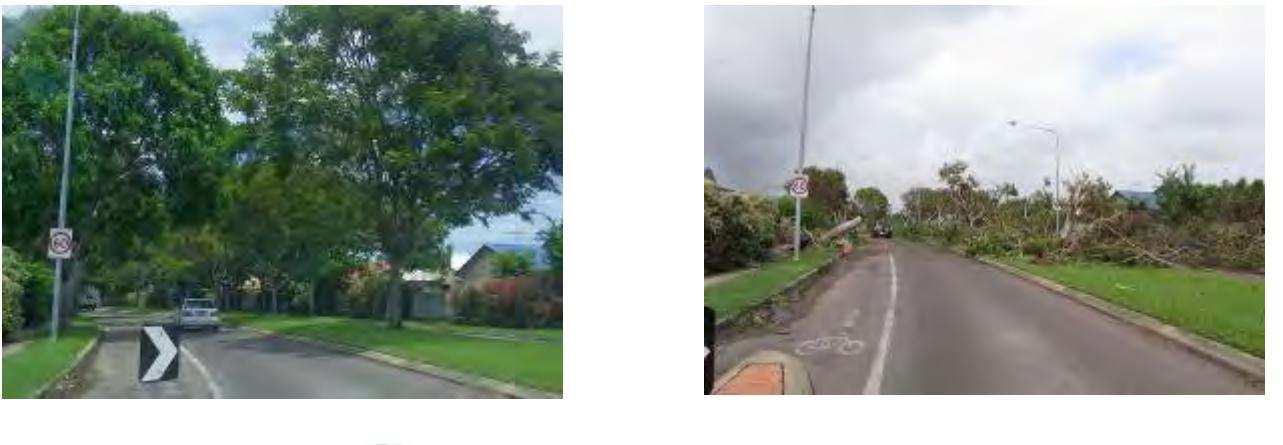
Figure 16 Low levels of damage to Melaleuca leucadendra (1.92%) on Fairfield Waters Drive (before and after)

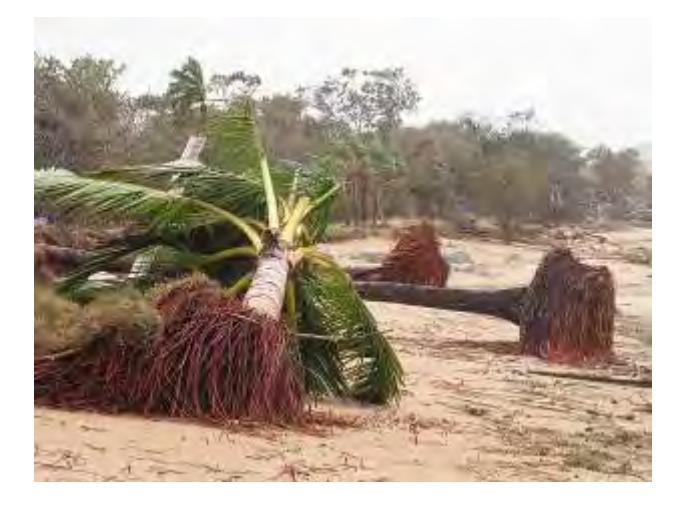
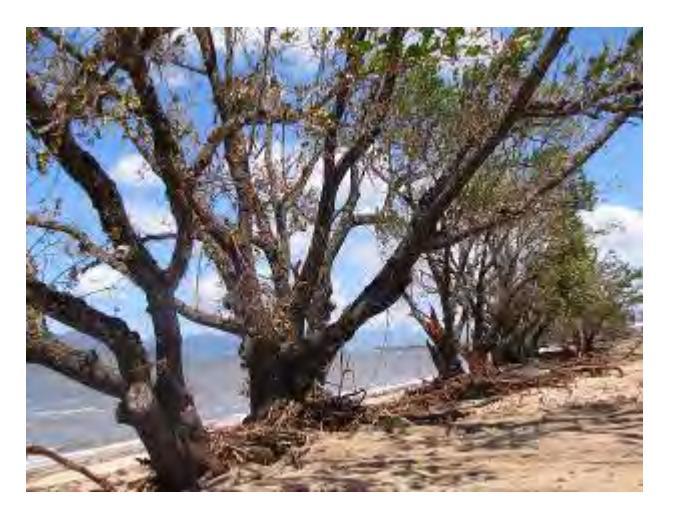
Figure 21 Differences in root architecture alter resilience to storm surge, sand depletion and cyclonic winds: coconuts in Townsville (Category 2) and Alexandrian laurels in Cardwell (Category 3)
