## The Innovative Gully

## Remediation Project

# Restoring eroded gullies cost-effectively reduces fine sediment entering the Great Barrier Reef over the long term

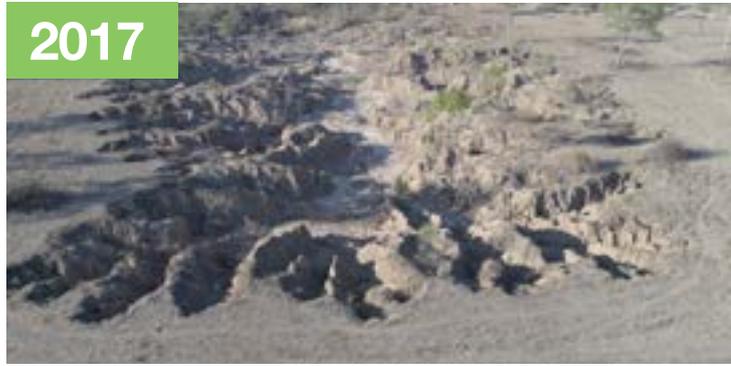
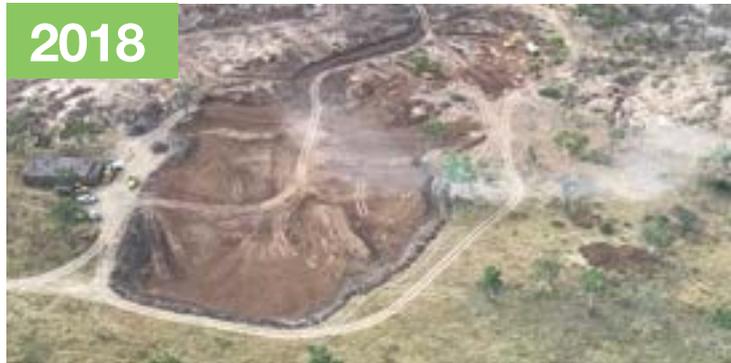
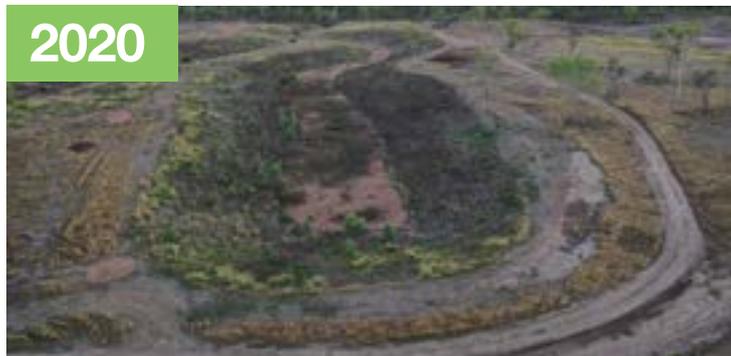
Changes over time for a restored gully at Strathalbyn Station.

The most cost-effective trials used 100 mm of rock capping over regraded batters treated with gypsum (including an additional 100 mm of topsoil in one treatment), mulching and seeding.

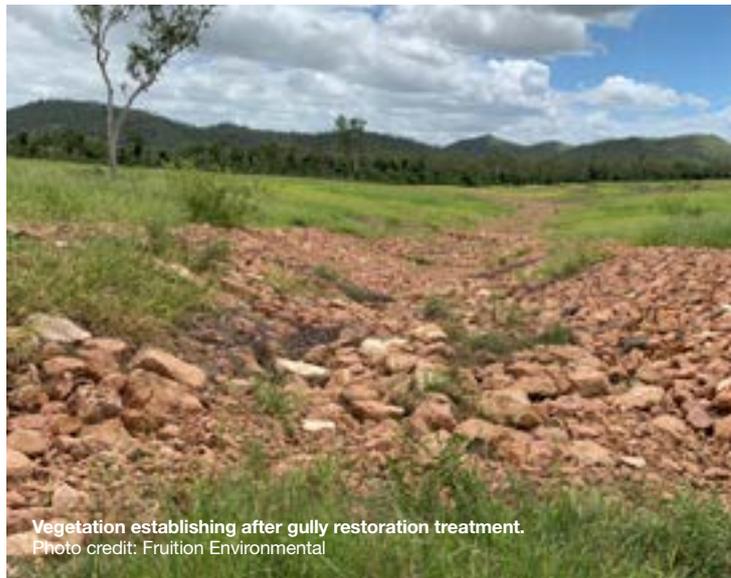
Vegetation establishing after gully restoration treatment.

Establishing self-sustaining perennial vegetation is critical for restoring gullies and reducing fine sediment export, especially long term. The project recommends:

- Ensuring rapid cover of the ground with perennial species, without too much initial concern for diversity.
- Using mulch and debris to make reinforced soil structures (bunds) to dissipate flows on long batters and allow dense ground cover to grow in inter-row areas.
- Including seed in a thin mulch bed — of bagasse, for example — to increase the success of germination and establishment.
