An assessment of tree susceptibility and resistance to cyclones

A study based on Severe Tropical Cyclone Yasi 2nd February 2011

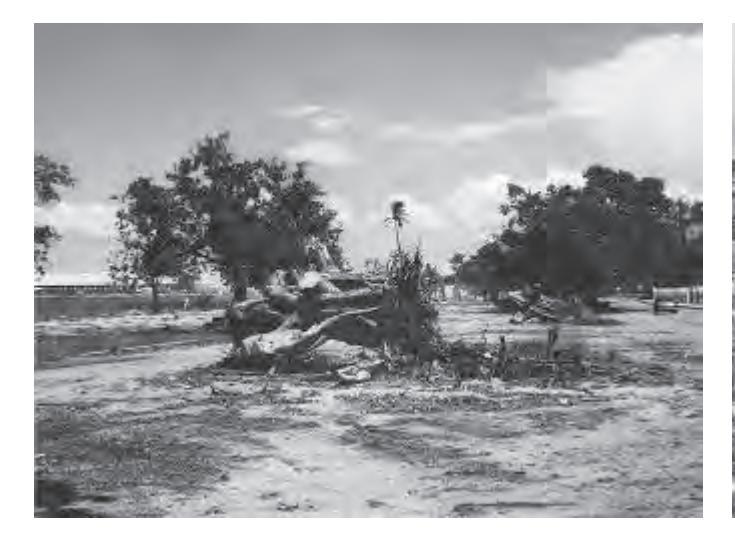
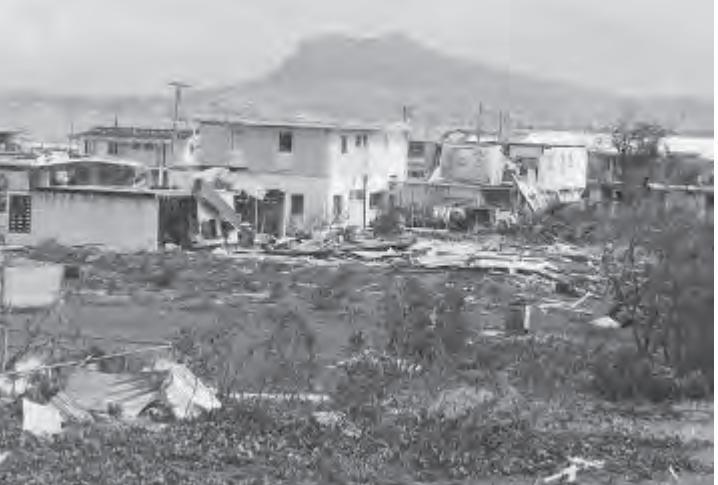
Figure 2 Impacts of Cyclone Althea on Pallarenda and Townsville Strand Dec. 1971. Reproduced with permission from CityLibraries Townsville, Local History Collection

heavy steel poles, lifted houses from stumps and stripped the leaves from trees (BoM 2011a). In addition to the wind damage, a storm surge of 3.66m was recorded at Toolakea Beach, with a smaller surge of 2.9m in Townsville Harbour. This storm surge caused extensive damage along the Strand and at Cape Pallarenda (BoM 2011b).

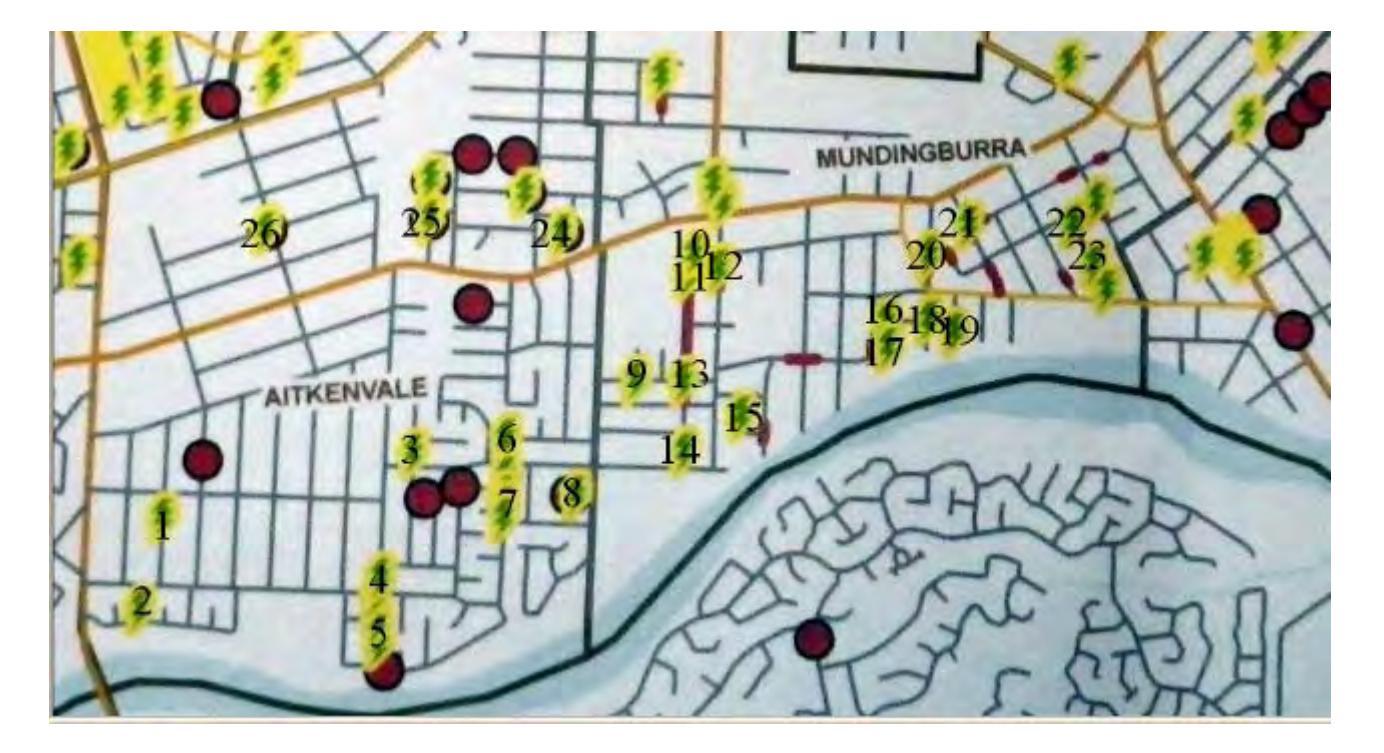
Figure 12 Survey locations for reported power outages (red dots = road blocked by tree)

Of the 26 locations, three locations were found not to be the location of a power failure, and one site had a power failure that was due to equipment malfunction. The remaining 22 locations showed that power failure was due to trees coming into contact with the power lines (Table 12). Two reported power failure locations were impacted by the same tree and will be analysed as being the same location hereafter. Therefore, it can be stated that of 22 locations of power failure, 21 of these failures (95.45%) were caused by trees.

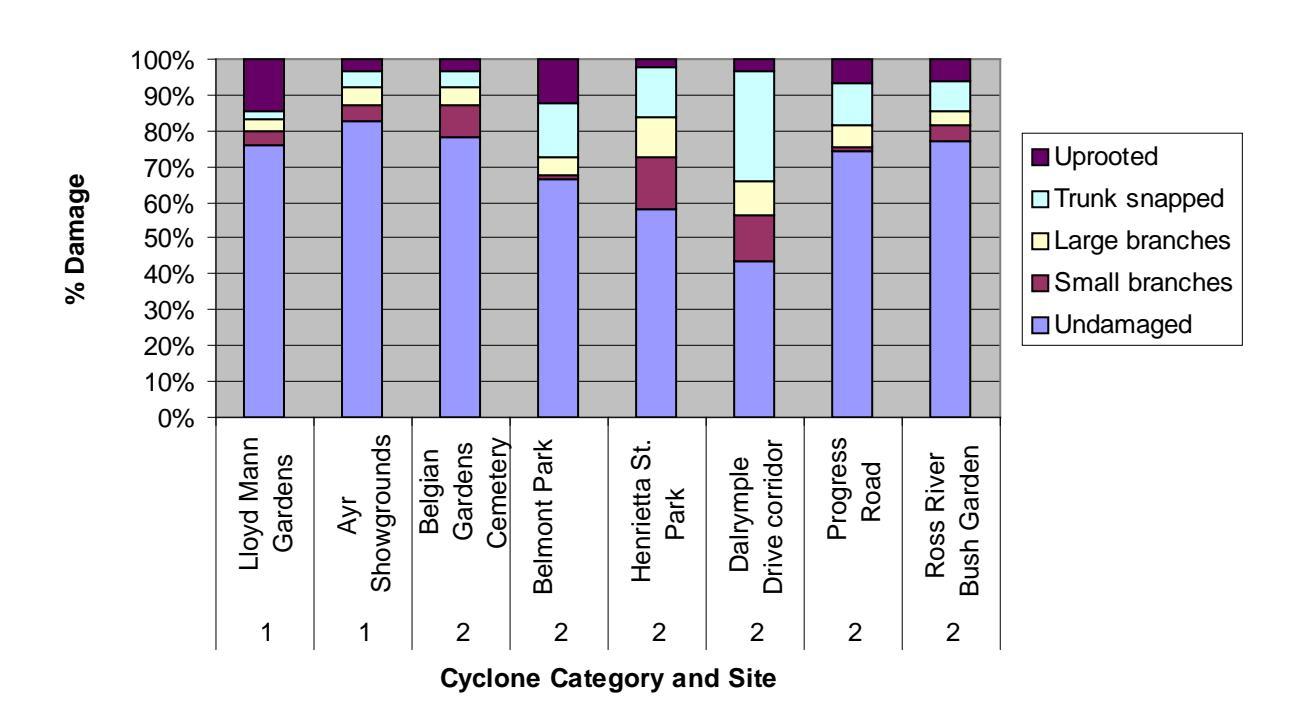
If a significant difference was expected between the sites impacted by category 1 equivalent cyclonic winds, and the sites impacted by category 2 equivalent cyclonic winds, then these differences are not apparent in this graph. Neither is there clear and obvious trends identifying similar patterns of damage on similar soil types. It should be noted, however, that the highest rates of uprooting were on sites that receive watering and/or irrigation – Lloyd Mann Gardens and Belmont Park. The lowest rates of tree emerging completely undamaged come from Henrietta St Park and the Dalrymple Road corridor, where the high rates of failure of a couple of species were by far the most influencing factor. These species – *Eucalyptus tereticornis* and *Peltophorum pterocarpum* have been identified at other parks, in the street surveys and in the literature as being susceptible to cyclones. It is proposed then that the selection of tree species is more likely to influence patterns of damage in trees than other potentially influencing factors such as mutual support, soil types and modes of watering and irrigation.

Figure 14 Percentage damage to trees in parks impacted by Cyclone Yasi

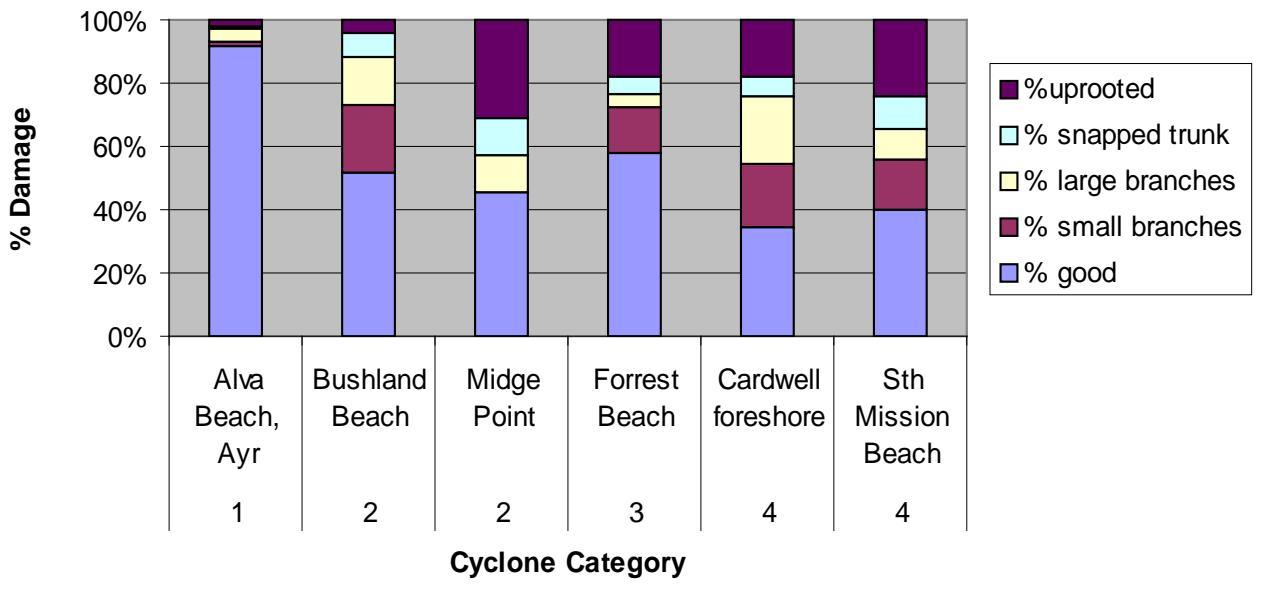
Figure 17 Percentage damage to trees on beachfronts impacted by Cyclone Yasi

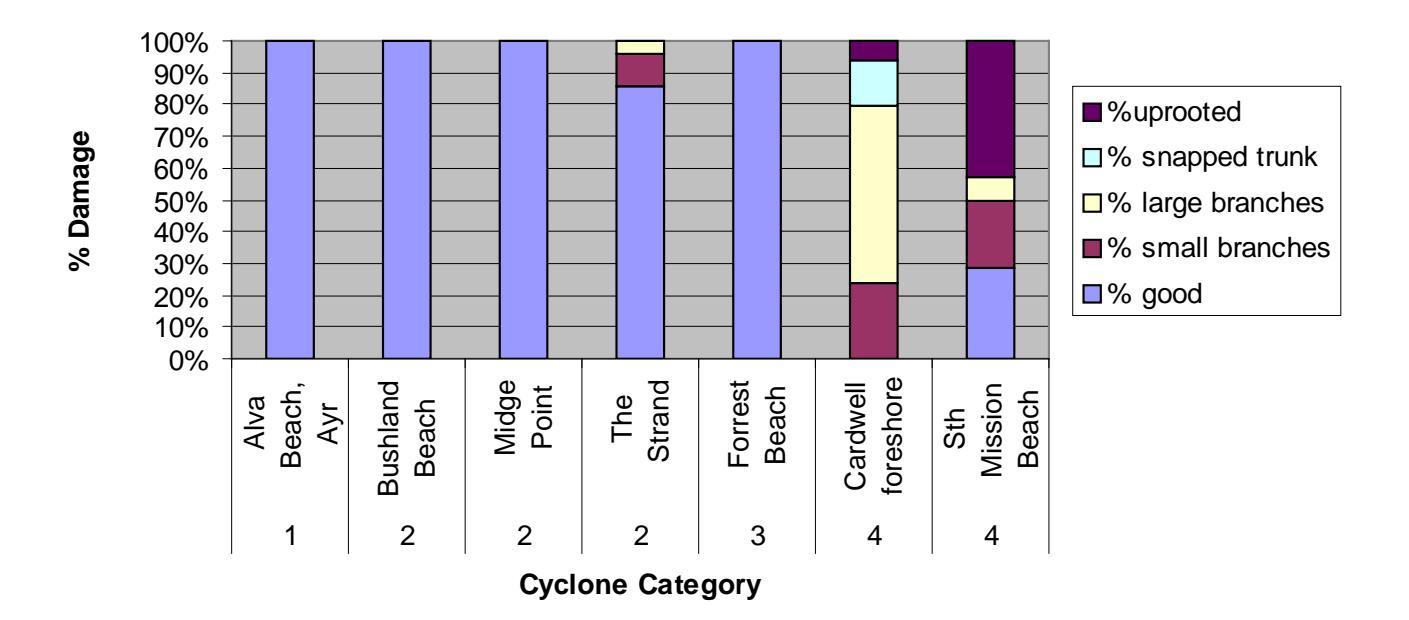
Calophyllum inophyllum

Figure 18 Changes in levels of cyclonic damage to Alexandrian laurel (Calophyllum inophyllum)

Alexandrian laurel has been widely described as being a cyclone resistant tree (Cairns City Council 1986, Calvert 2006, Cameron *et al* 1982, Donahue 1975, Kupsch 2006, Roach 2006, Tucker *et al.* 2006, Stocker 1976, and Van der Sommen 2002). Alexandrian laurel trees were almost entirely undamaged by category 1-3 cyclones, but showed a marked tendency for broken branches in Category 4 winds. Only on the Cardwell foreshore were there no undamaged plants. At this location, many of the Calophyllum trees had been bare-rooted by sand removal, and the bark of many trees had been torn off. This was presumably due to the hammering of the storm surge and wind driven rains pounding on their trunks. Many of the Alexandrian laurels had long limbs reaching out towards the ocean that were torn off during the cyclone, accounting for the large proportion with large broken limbs. At South Mission Beach, where the eye of Yasi actually crossed, 42.85% of the Alexandrian laurels were uprooted, as a consequence of the beach being eroded out from under them. Without the supporting sand, the bare rooted trees had no support and fell over. In many individual circumstances, the broad spreading root systems allowed trees to remain upright, even when bare rooted, allowing an opportunity to save the trees through sand replenishment programs.

It is worth noting that the Alexandrian laurels at Cardwell that were bare rooted, with broken limbs and stripped of bark during Cyclone Yasi were noted to be recovering when examined four months later (Betsy Jackes pers. Comm.).

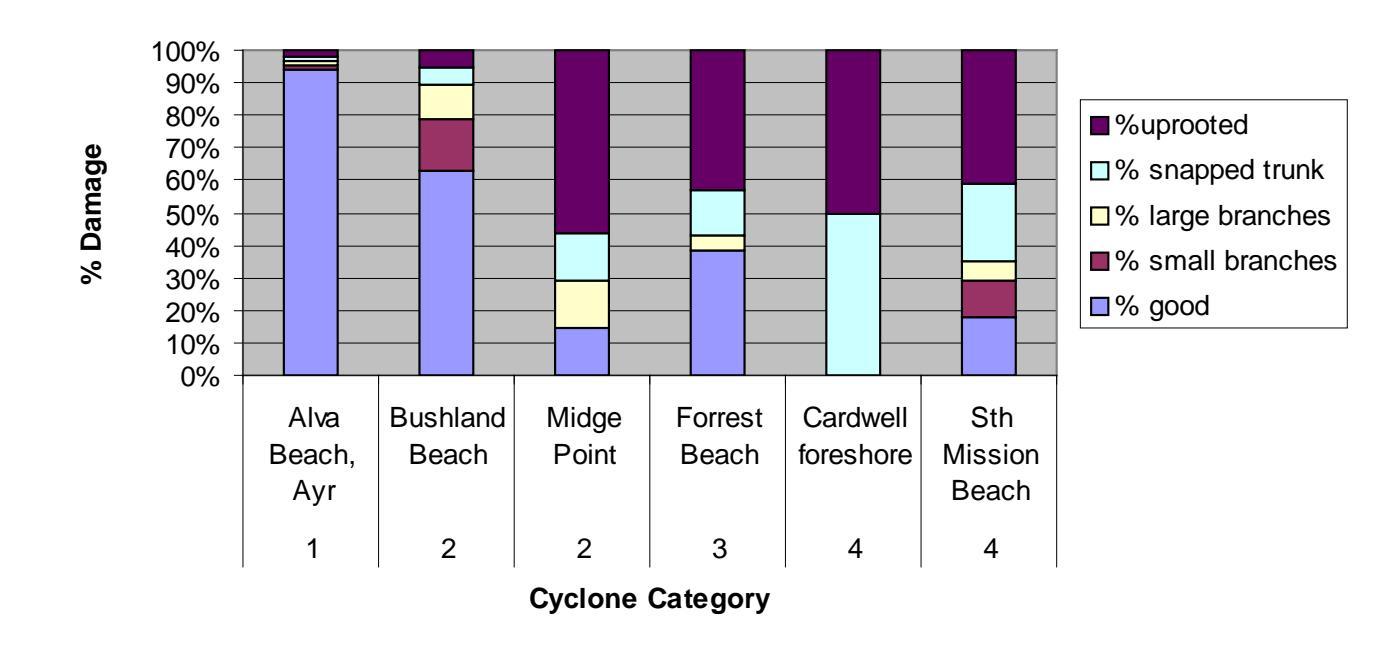
Casuarina equisetifolia

Figure 19 Changes in levels of cyclonic damage to beach she-oak (Casuarina equisetifolia)

Beach she-oak is a naturally dominant beachfront species throughout north Queensland, and is described by Jackes (2011) as having medium resistance, showing mixed results but noted for having flexible foliage and branchlets. It is, however, noted for being prone to stem and branch breakages (Cameron *et al* 1981, Stocker 1976). During the present study, they suffered only very minimal damage during Category 1 and low Category 2 winds, but at the upper end of Category 2 wind speeds (Midge Point), they dramatically increase the rate of uprooting and snapped trunks. Some variation of these results should be expected in Category 3 and 4 cyclones as even at South Mission Beach, three of the 17 trees were entirely undamaged.

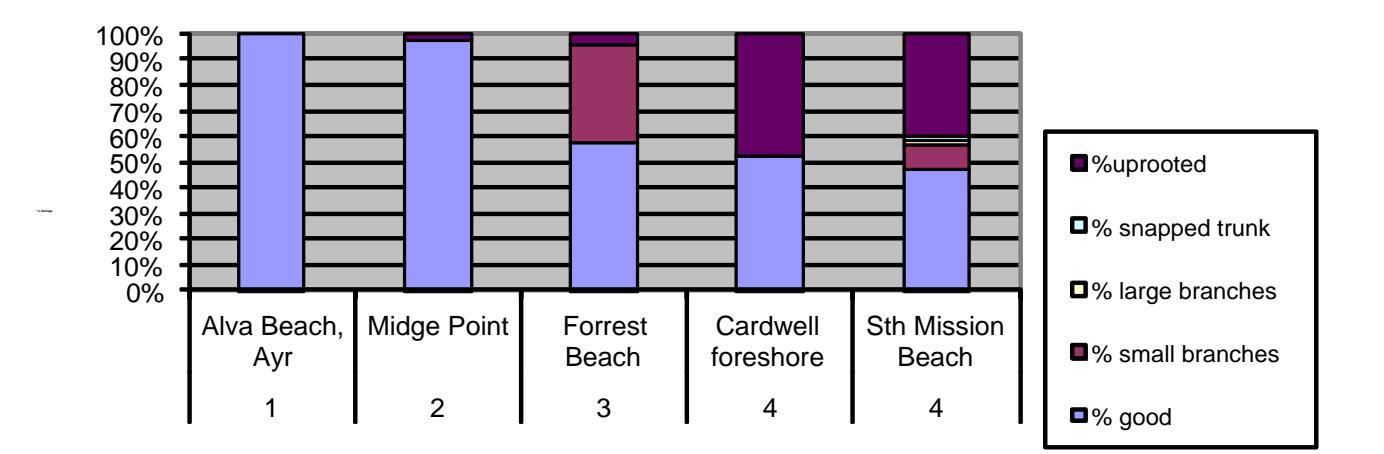
Cocos nucifera

Figure 20 Changes in levels of cyclonic damage to coconut (Cocos nucifera)

Coconuts are not native to Queensland (Bostock & Holland 2010), but are widely planted along tropical beaches. While Cameron *et al* (1982) describes them as being moderately stable, others describe them as being susceptible to uprooting (Calvert 2006, Stocker 1976). In Category 1 and 2 cyclones, coconuts sustained none or very little damage. During Category 3 events, nearly half the trees had minor broken fronds, but trees were extensively uprooted during category 4 events. At these locations, the strong wave and storm surge action had resulted in large quantities of beach sand being removed, resulting in the coconuts being bare-rooted and toppling over. Bare-rooting resulting in toppling was also evident at several other beach-front locations assessed during green waste assessments, and on beach fronts this remained the primary cause of damage. Snapped trunks were more common in urban areas. The small fine roots and dense, compact root ball makes this species highly susceptible to the impacts of storm surge and bulk sand removal. A higher proportion of trunk snapping might be expected if uprooting did not occur, and greenwaste surveys show this is more likely to occur if the trees are fully laden with nuts.

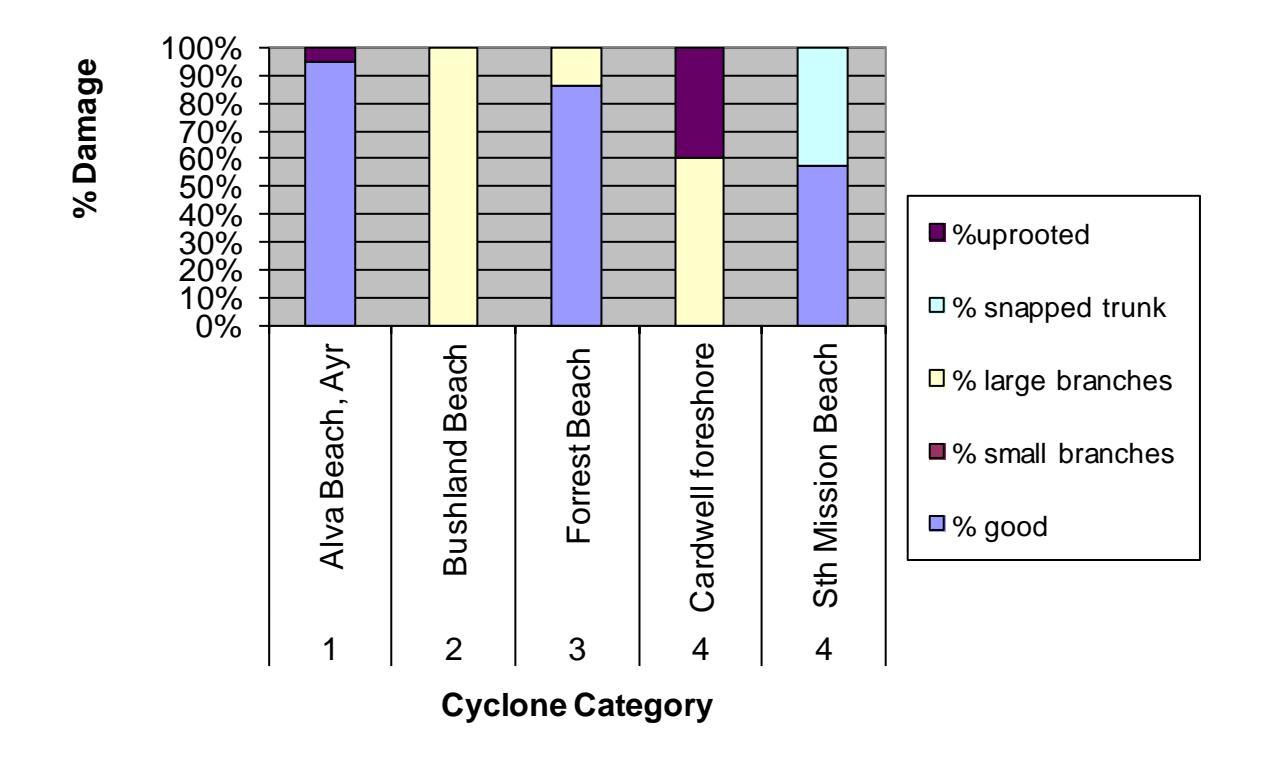
Pandanus tectorius

Coastal screw pines are a distinctive and common native beachfront species. Other pandanus species have been noted as being resistant to cyclone damage (Tucker *et al.* 2006). Trends in damage to coastal screw pine with increasing cyclonic damage are difficult to interpret. During Category 1-3 cyclones, trees are either mostly undamaged or suffer broken branches, but at higher cyclone categories, the rate of uprooting or trunk breakage increases. Uprooting was a consequence of being bare rooted by storm surge impacts on sand erosion. The clumping and branching habits of the coastal screw pines generally allows these trees to recover from breakages.

Figure 22 Changes in levels of cyclonic damage to coastal screw pine (Pandanus tectorius)

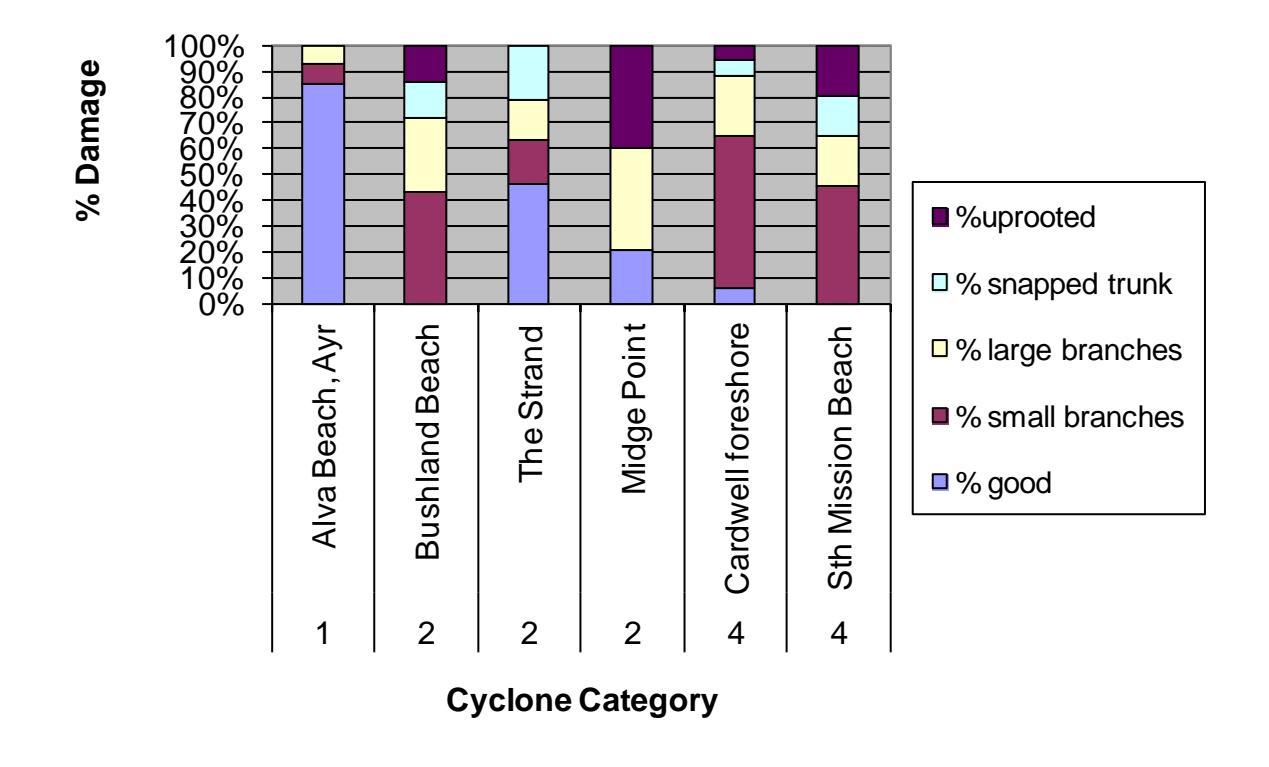
Terminalia catappa

Sea almonds are common along beach front parks, both naturally and planted. The literature relating to sea almonds in cyclones is conflicting. While Cairns City Council (1986) and Jackes (2011) describe them as wind resistant, others describe them as unstable (Cameron *et al* (1982) and prone to severe failure (Roach 2006). A moderate view is taken by Tucker *et al*. (2006), who noted that during Cyclone Larry, the leaves were shredded but the main trunk remained intact. During Cyclone Yasi, trends in damage showed a general decrease in undamaged trees with increase in cyclone intensity. At every location, broken branches seemed to be the most common type of damage, supporting the observations of Tucker *et al*. (2006). Although damage was minimal in Category 1 cyclones, there was no discernable trend in uprooting or trunk breakage with increased cyclone strength but a general increase in the rate of branch breakage. This tree has large leaves that can offer a lot of wind resistance, but an open tiered branching architecture that reduces wind loading. The loss of branches during high winds further reduces the wind loading, allowing the main trunk to survive in most cases.

Figure 23 Changes in levels of cyclonic damage to sea almond (Terminalia catappa)

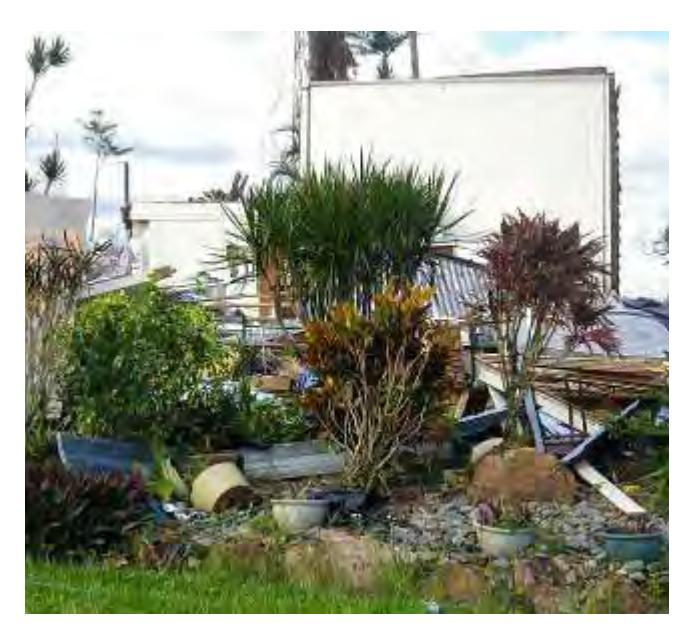
Figure 26 Low growing plants are often cyclone resistant but provide little or no protection to property

The current belief that trees are all hazards during cyclones needs to be targeted, and replaced with the message that trees are a valuable asset during cyclones and that a minority of tree species are dangerous and unacceptable hazards. Replacing trees with low growing shrubs may reduce the damage that these plants can have on infrastructure, but are incapable of delivering any benefits such as debris catchers or wind breaks during intense cyclone events. Townsville residents should be informed about the likelihood of failure of these highly susceptible species, so they can make informed decisions about their retention or removal. The role of highly susceptible tree species in causing power failure should be
