# Project Update May 2020

**COMMUNIQUE FOUR**

## The Innovative Gully

# **Remediation Project**

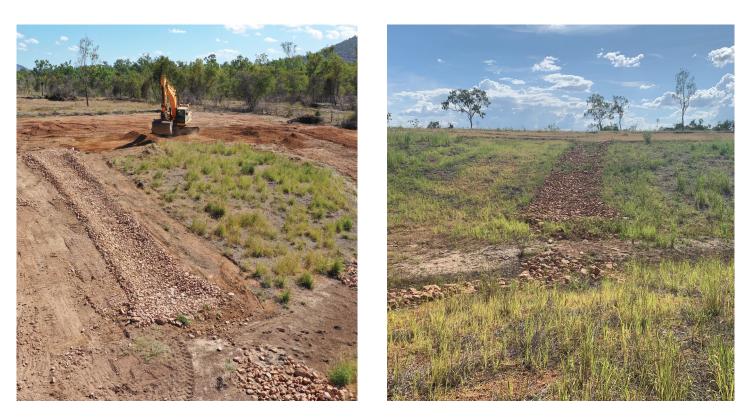
Batter repair using diversion bunds and a batter chute (left image 2019, right image 2020). Photo credits: Fruition Environmental Pty Ltd 2020

Maintenance and minor repair of completed remedial works were required in a number of the treatment gullies. The maintenance works were predominantly focused on addressing areas of flow concentration that became particularly obvious after the 2019 monsoon rain event.

Repair works were relatively minor with approximately \$20,000 spent on small-scale modifications to the works completed in 2017 and 2018. The strategies used to combat flow concentration included minor diversion bunds, improved road drainage, porous checks structures, batter chutes, additional hay/bagasse placed on long slopes, and supplementary seeding to improve vegetation cover. Future works and designs will consider how to avoid minor drainage depressions adjacent to batters, as generally capping materials are not sufficient to prevent rilling until ground cover and other vegetation is established.

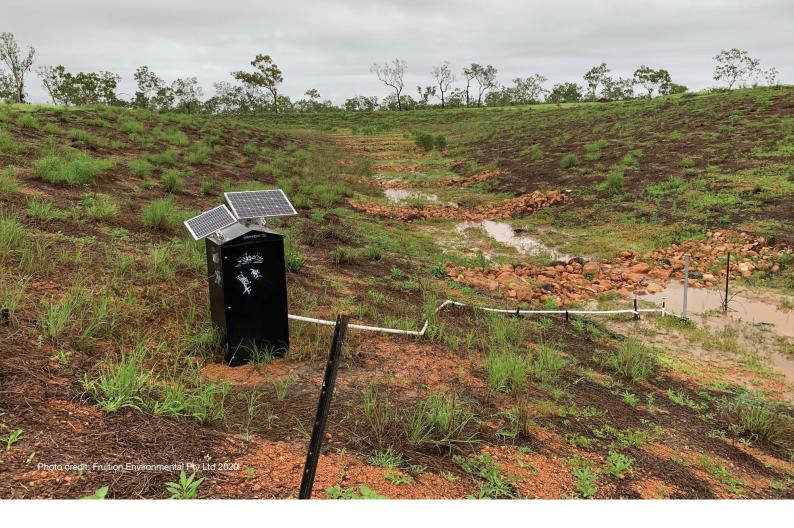
- wet-season rainfall event monitoring, focusing on fine sediment and nutrient export from both treated and untreated gullies
- utilising post-construction and end-of-wet high-resolution LiDAR to estimate erosion rates through comparison of Digital Elevation Models between capture periods (targeting both treatment and control sites)
- end-of-wet and end-of-dry vegetation survey and land condition assessments.
